HAWKINS WEIR **ENGINEERS, INC.**

Re: Structural Evaluation
Old Sallisaw High School
HWEI Project No. 2014074

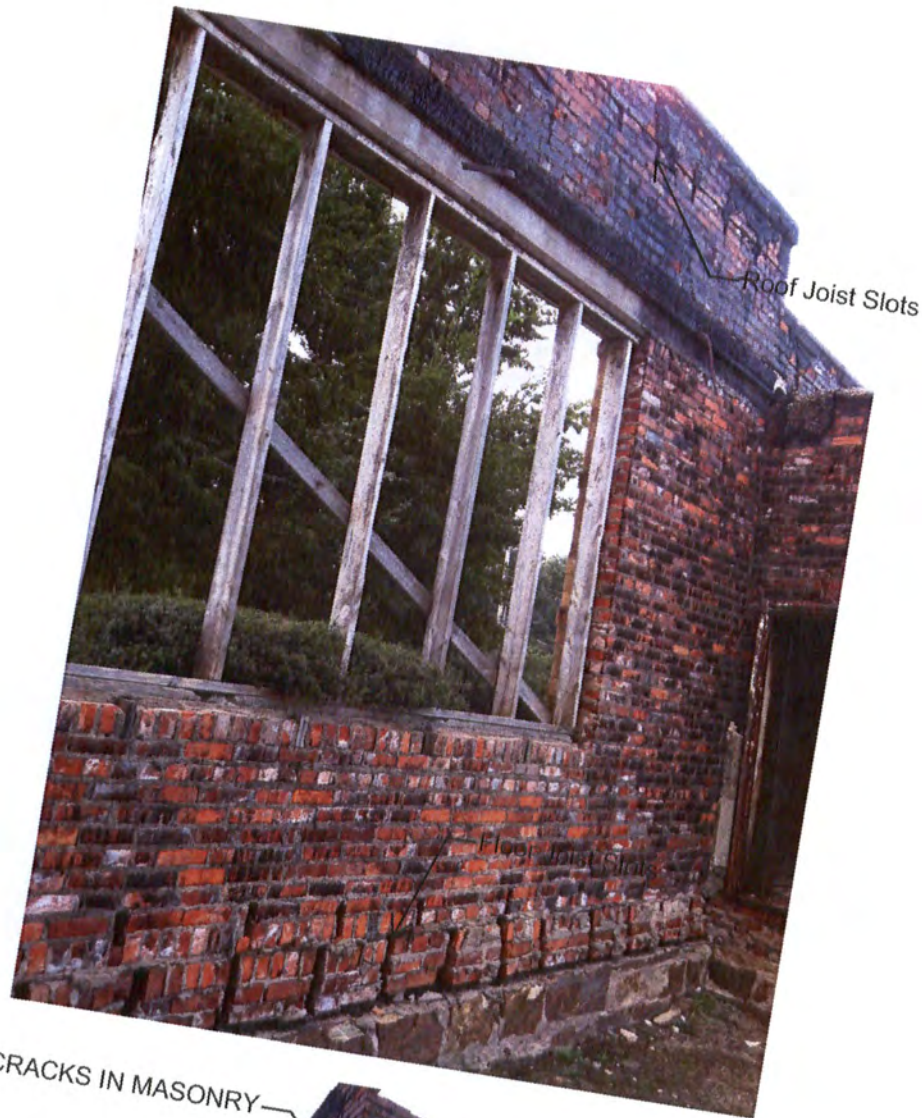
The existing brick walls prior to the fire were supported by a floor diaphragm at the base and a roof diaphragm near the top of the existing masonry walls (please see attached Picture 1). The foundation was also designed for vertical load only and not for the overturn caused by a free standing wall. The existing masonry walls do exhibit substantial cracking in multiple locations (please see attached Pictures 2, 3, and 4). For the above stated reasons, we conclude that the existing free standing masonry walls are a danger to public safety and should be demolished as soon as possible.

PICTURE 1
Shows Existing Masonry Wall
where the floor diaphragm and
roof diaphragm were connected.

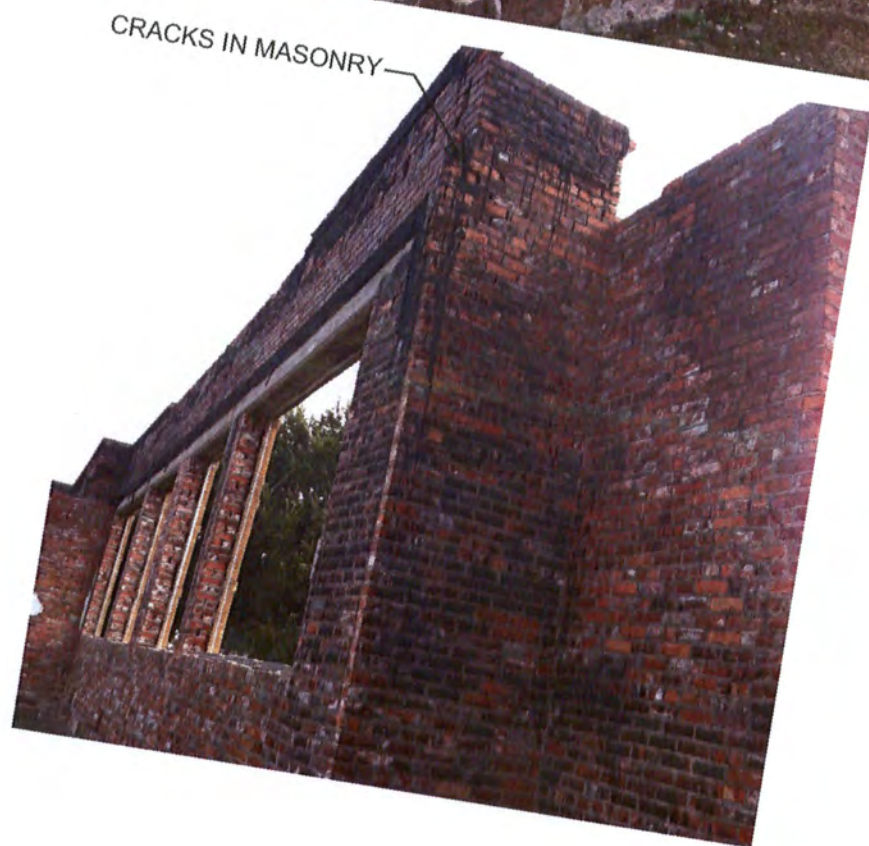
PICTURE 2
Shows Cracks in the Existing
Masonry Wall.

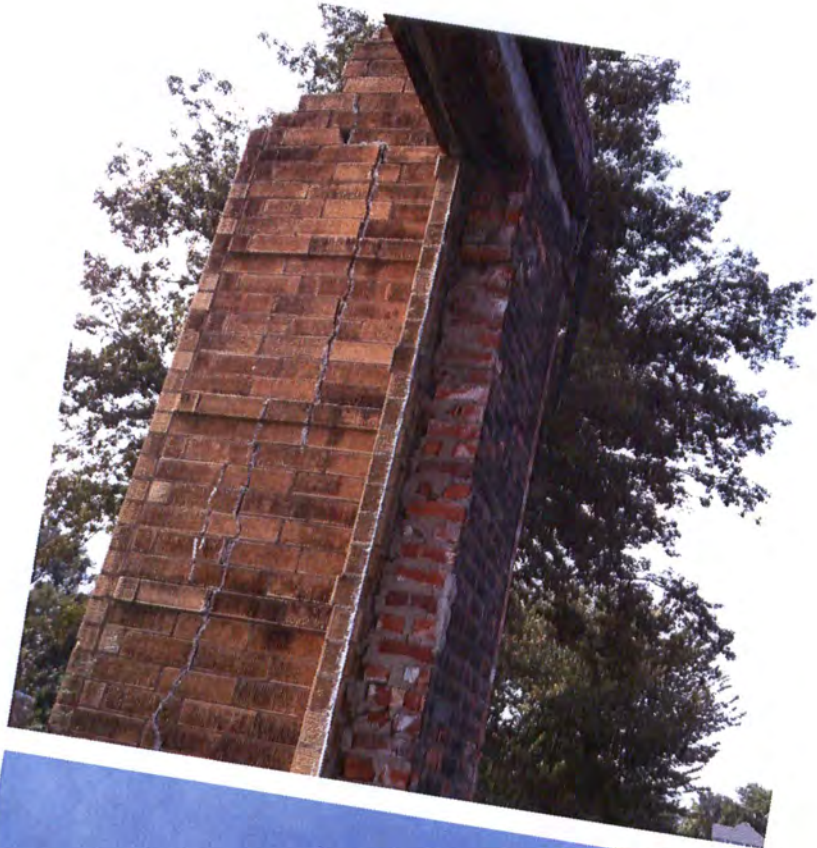
PICTURE 3
Shows Cracks in the Existing
Masonry Wall.

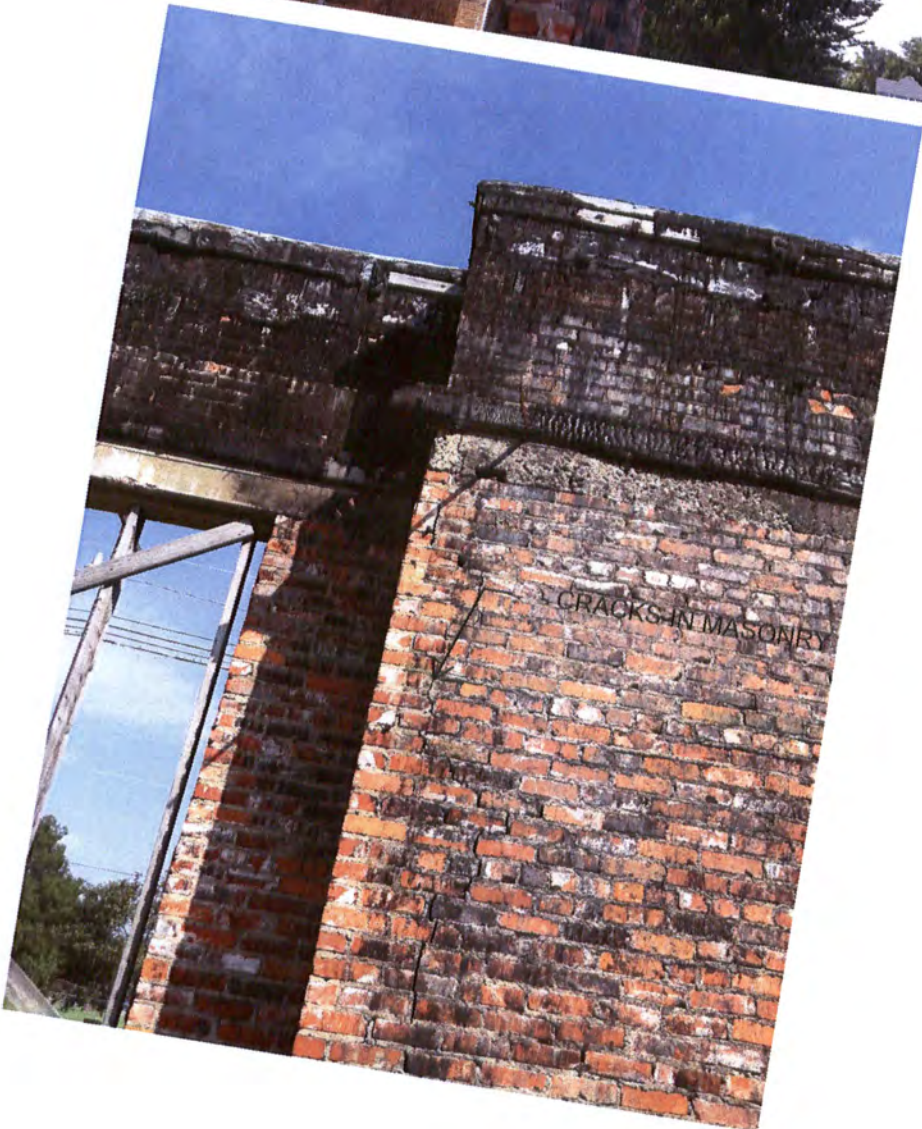
PICTURE 4
Shows Cracks in the Existing
Masonry Wall.

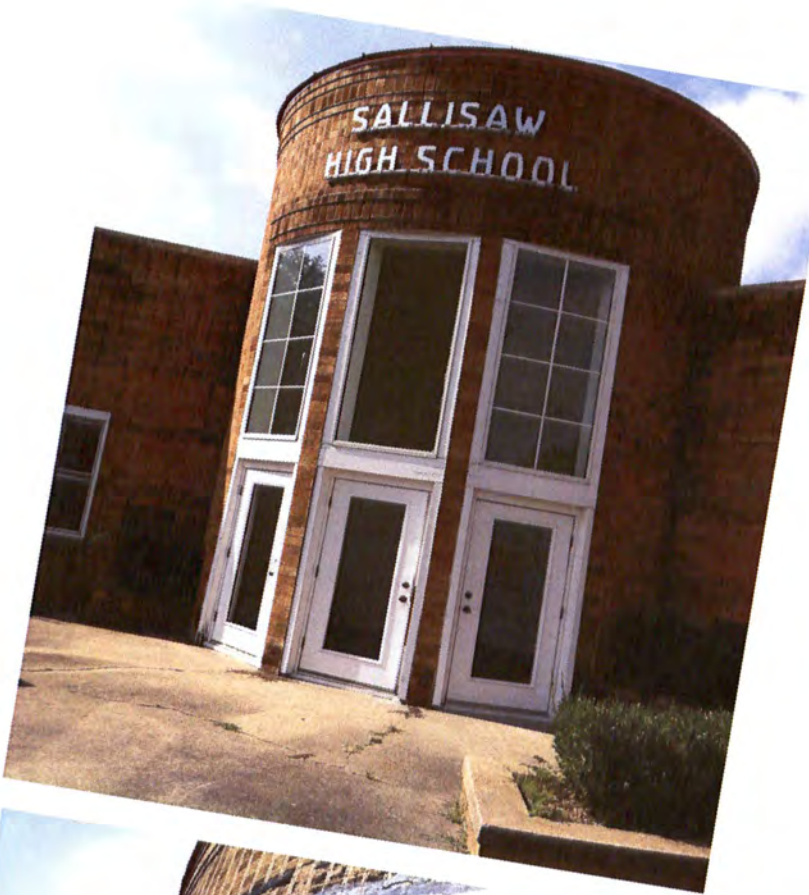
PICTURE 5
Existing Rotunda Front - Broken
Glass should be repaired.

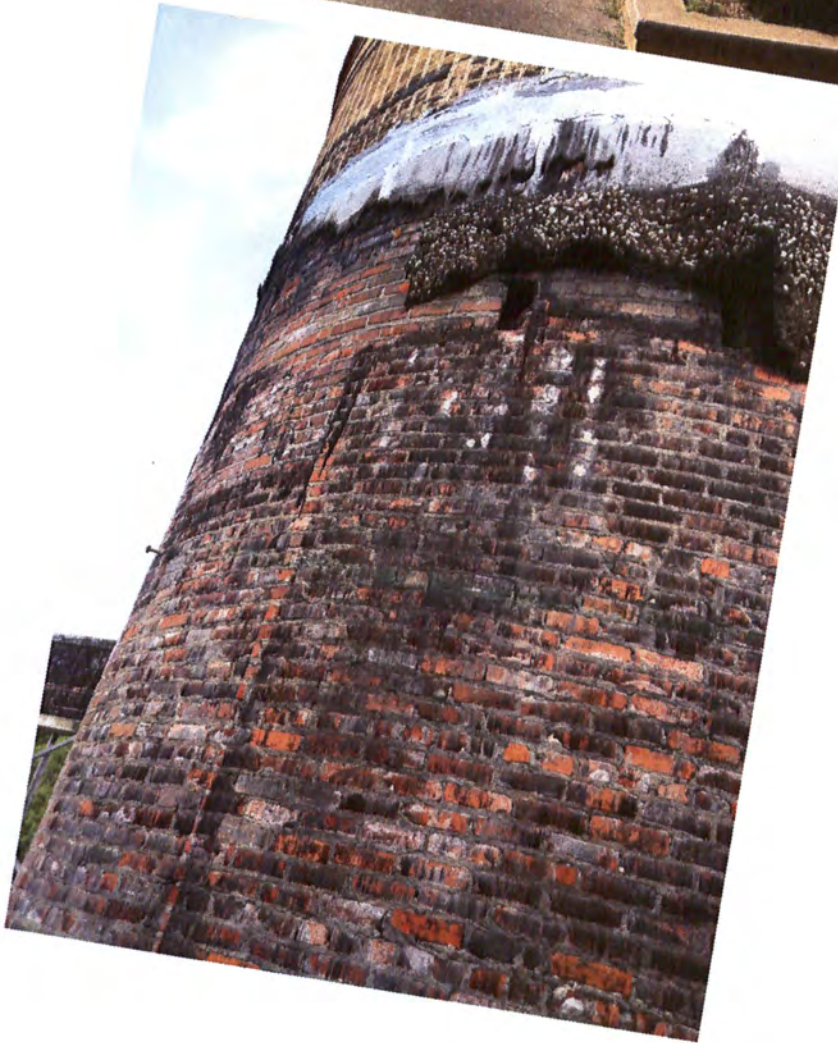
PICTURE 6
Back of Rotunda showing slots in
brick for roof beams.

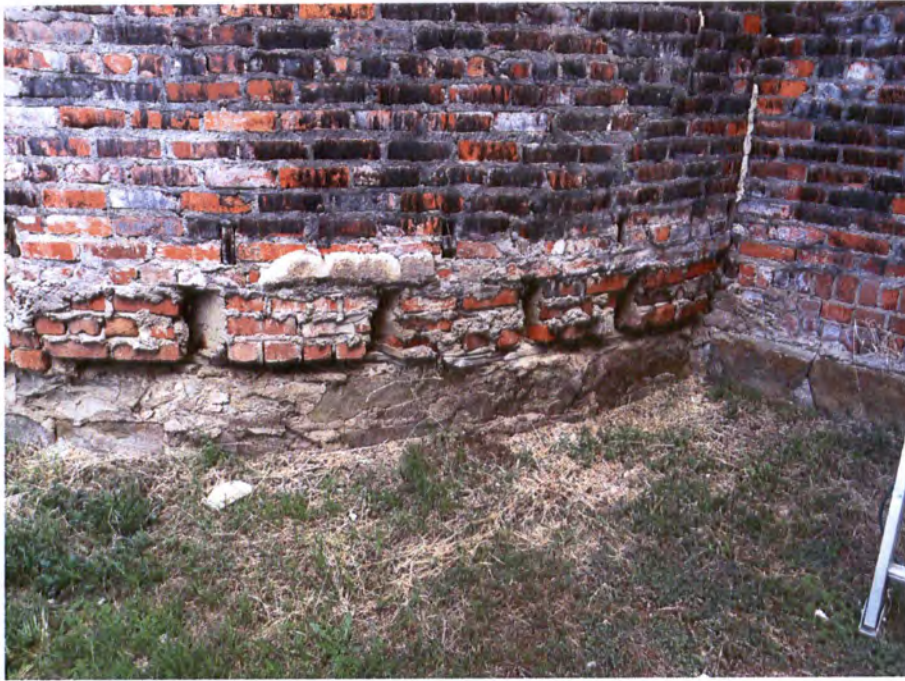
PICTURE 7
Back of Rotunda showing slots in
brick for floor beams.
